# Five Mile Slough and Five Mile Creek

## Project Study Report

**Siegfried Engineering, Inc.**  
3244 Brookside Road, Suite 100  
Stockton, CA 95219  
(209) 943-2021

Date Prepared: 08/24/2018

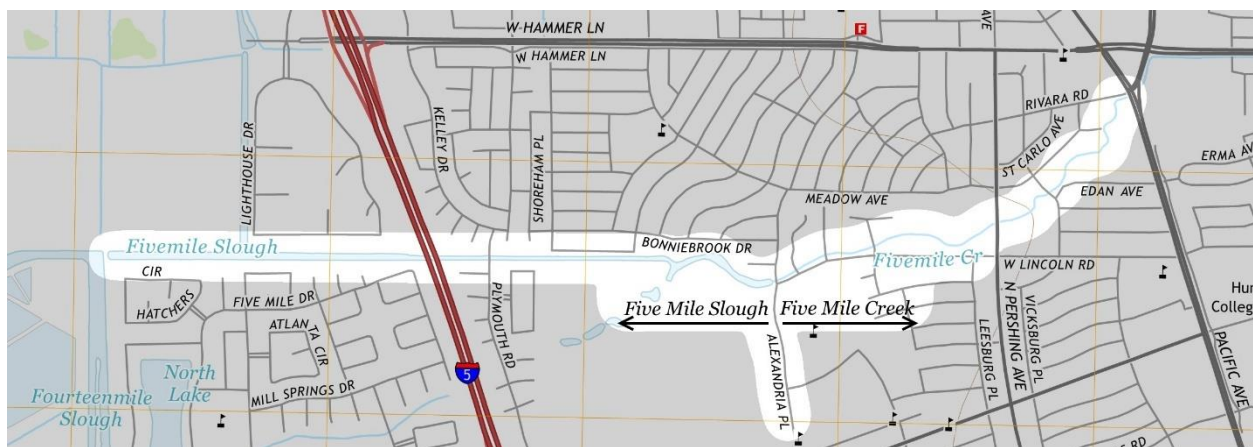
Figure 1. Geographical extent of Five Mile Slough and Five Mile Creek.

From Pacific Avenue, Five Mile Creek meanders through Lincoln Village to Alexandria Place, passing underneath bridges on private property and through culverts on Caran Avenue, Pershing Avenue, and Alexandria Place. Continuing as Five Mile Slough, the waterway then straightens, flows next to Swenson Golf Course, and passes through culverts on Plymouth Road and Interstate Route 5. Water in the creek and the slough consist primarily of stormwater runoff from a roughly 1,548 acre watershed area. At the

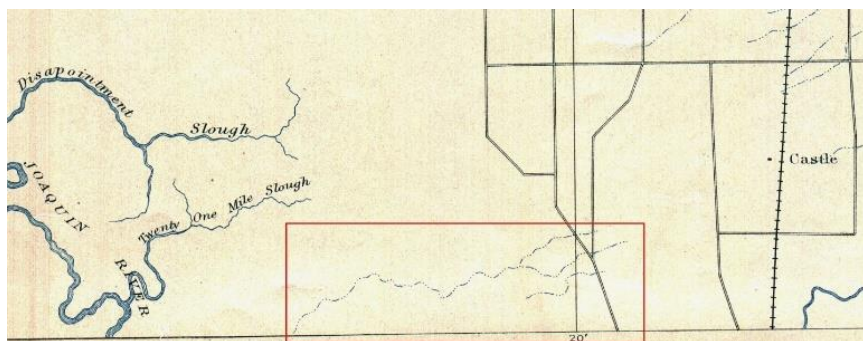
Figure 2. 1898 topographic map of the Five Mile Slough and Five Mile Creek watershed showing the historic Castle area surveyed in 1894 with the historic Five Mile Creek denoted below with a red rectangle. The map shows that prior to the time the earth fill was constructed at the present-day location of Five Mile Dam, Five Mile Creek appears to meander and flow like a creek downstream of the present-day location of Alexandria Place. It is not yet known whether this portion of Five Mile Creek is the same as the present-day Fourteen Mile Slough downstream of Five Mile Dam, and where it ultimately discharged to. The map shows there was little to no development at this time (USGS 1898).

Historical records documenting the Five Mile Slough and Five Mile Creek watershed in the early 1900's are limited. Refer to the USGS topographic maps shown in Figure 2 and Figure 3 below. Five Mile Slough and Five Mile Creek were named after Five Mile House, which existed near the present-day Five Mile House Apartments. Between 1894 and 1907, an earthen dam was constructed on Five Mile Slough at the present-day location of Five Mile Dam, and the channels were straightened so that the water could be used for agricultural irrigation (USGS 1910; Pulver 1998). The construction of the dam effectively disconnected Five Mile Slough from Fourteen Mile Slough, removing Five Mile Creek and Five Mile Slough's natural outlet, and created a water body that does not flow like a river.

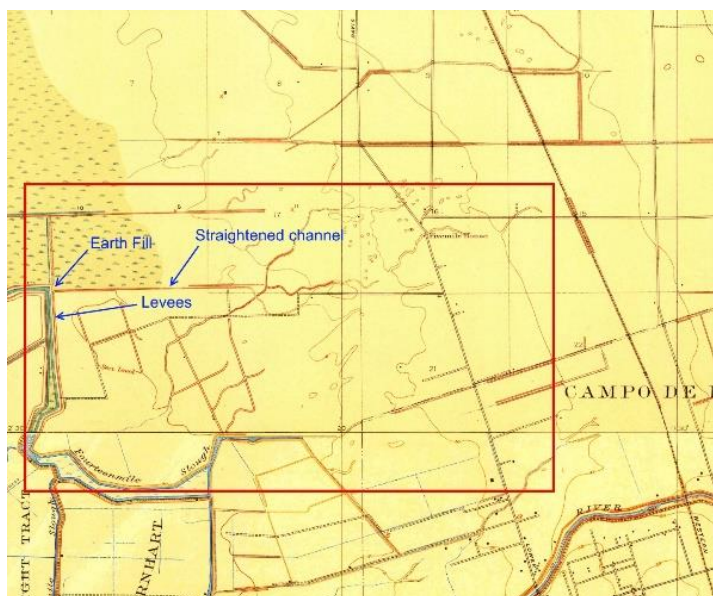
Figure 3. 1910-1913 topographic map of the Five Mile Creek and Five Mile Slough watershed (USGS 1910; USGS 1913). The map shows that Five Mile Creek was straightened, levees were constructed, and an earth fill was installed at the present-day location of Five Mile Dam so that Five Mile Slough could be used for irrigation (Pulver 1998).

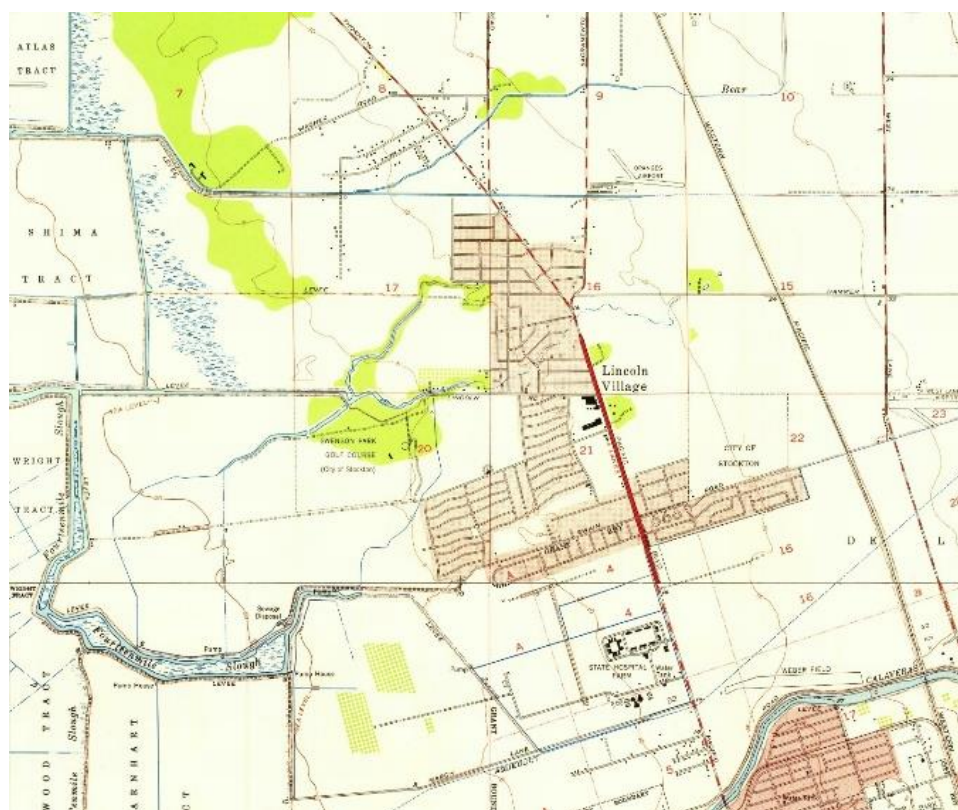
Figure 4. 1952-1953 topographic map of the Five Mile Creek and Five Mile Slough watershed, published by the United States Geological Survey. The vicinity was surveyed in 1952 and 1953. The map shows the beginning of the development of Lincoln Village and the addition of Swenson Golf Course.

Between 1952 and 1968, most of the Five Mile Slough and Five Mile Creek watershed was developed (Refer to Figure 4 and Figure 5, below). In the 1950's, Lincoln Village and Parkwoods were developed (USGS 1953). In 1952, Swenson Park Golf Course opened (City of Stockton 2017), and in 1954, Lincoln High School opened (Lincoln Unified School District 2017). Between 1958 and 1959, there were concerns

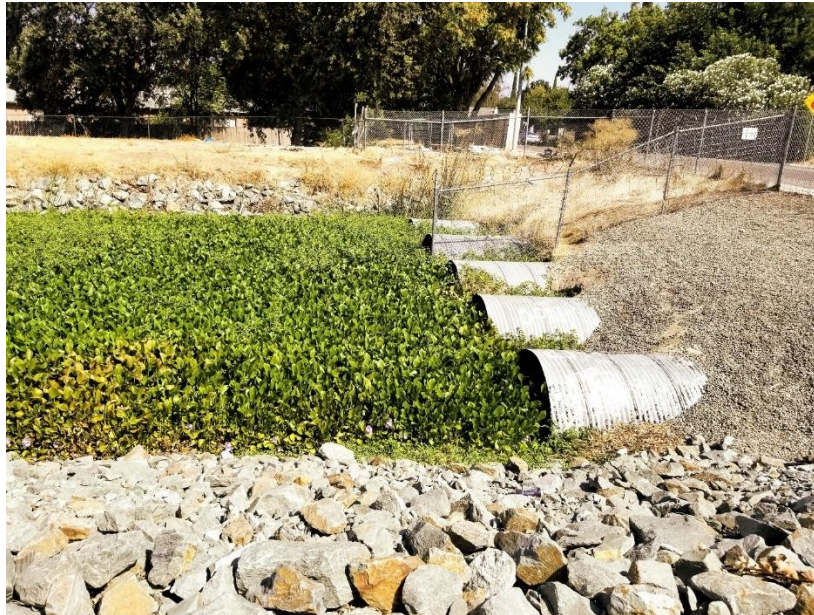
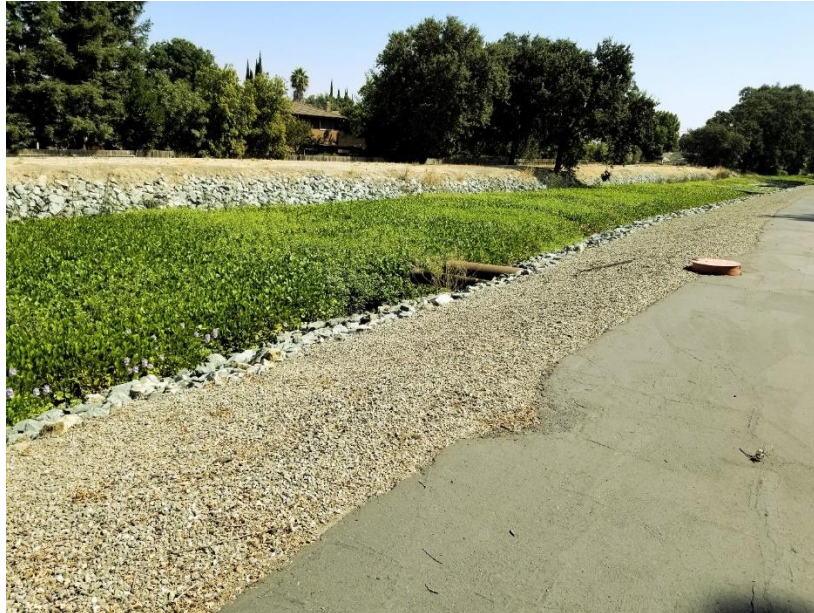
Figure 8. Water hyacinth in Five Mile Slough at Plymouth Road at the downstream culverts and upstream of the culverts, taken in September 2017. Water hyacinth is visible from bank to bank, showing its tendency to grow uncontrolled. Current control efforts have included spraying and physical removal, but it has only provided temporary control (Lewis 2002; Kleinschmidt & Huffman 2003; 16 Nov. 2017 public outreach meeting at Mable Barron).

In 2002, residents raised awareness to both the City and the County about water hyacinth (Refer to Figure 8, below), and J. Stovall, an attorney representing Reclamation District 1608, sent a letter to the County requesting that the County remove the water hyacinth due to the concern that the water hyacinth could block Five Mile Dam and/or the roadway culverts, resulting in flooding through Swenson Golf Course into the District (Stovall 2002). In an April 12, 2002 staff report to the City Mayor and City Council, the City Manager proposed a combination of aquatic herbicides and physical removal of water hyacinth. The report stated that in addition to getting the necessary permits to spray herbicides, it would also require getting permission from each property owner, private, City, County, or Reclamation District 1608, that own portions of Five Mile Creek and Five Mile Slough to spray and physically remove water hyacinth (Lewis 2002). The report expressed concerns that sprayed plants would sink to the bottom, which would not resolve the aesthetic impacts due to the shallow depth, and would also decay and deplete the dissolved oxygen in the stream, which was recently added to 303(d) list of impaired water bodies for low dissolved oxygen (Lewis 2002; SWRCB 2002). The San Joaquin Area Flood Control Agency prepared and implemented a California Environmental Quality Act (CEQA) Initial Study and Mitigated Negative Declaration for an aquatic weed control program (Kleinschmidt & Associates 2003; Giottonini 2003). To date, however, water hyacinth and other aquatic weeds remain a problem (16 Nov. 2017 public outreach meeting at Mable Barron).
